# **PULVERIZED COAL BOILER OPTIMIZATION THROUGH FUEL/AIR CONTROL**

**Barry E. Pulskamp, P.E.  
Director, Mechanical Engineering  
Cincinnati Gas & Electric Company**

**This paper presented at the Thirtieth Annual Kentucky Coal  
Utilization Conference, University of Kentucky, April 24 and 25, 1991.**

1.0 BACKGROUND AND  
DESCRIPTION OF UNIT

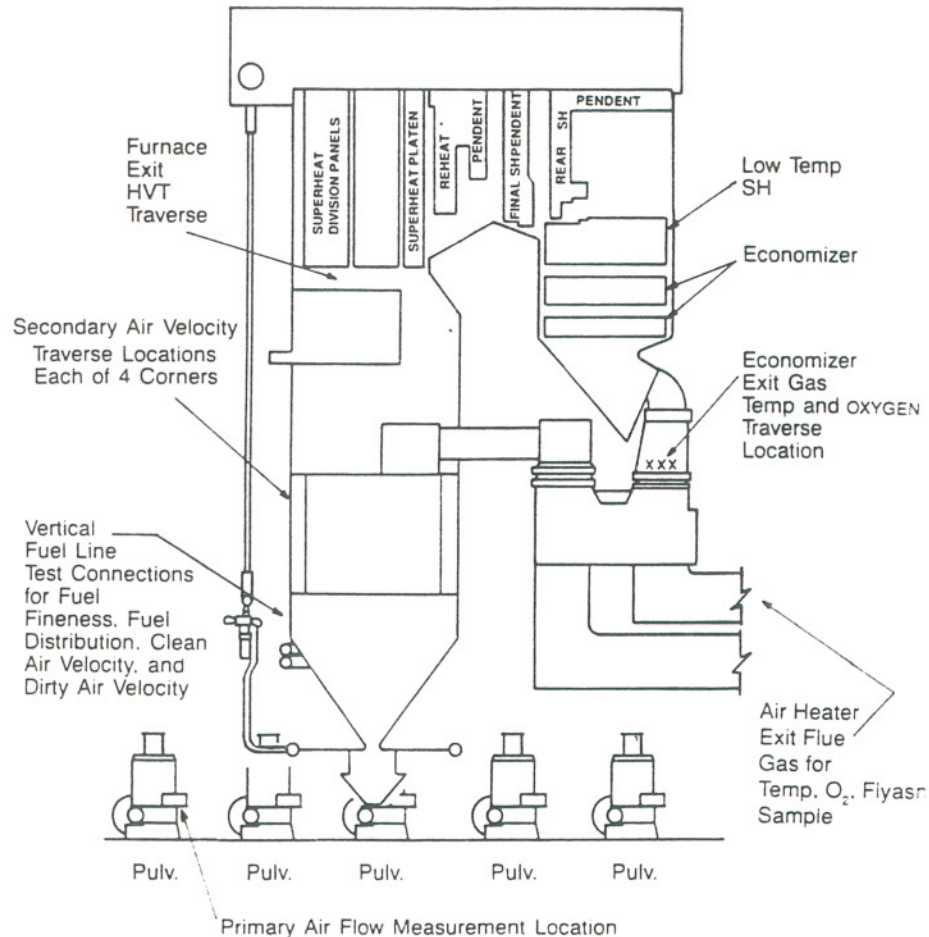
The burner offset air nozzles which were installed in 1987 were intended to increase furnace absorption through reduced slag accumulation on the waterwalls. Testing in the Spring of 1988 indicated that the furnace exit gas temperatures were well in excess of the ash fusion temperature, and the desuperheating spray flows were still higher than desired. The testing locations are shown on the figure below.

Comprehensive diagnostic testing was chosen for the advantage of determining critical cause and effect relationships in real time. For example, the furnace exit gas temperature at the nose arch was found to be in excess of 2,500°F at full load at many points. The ash fluid temperatures for many fuels that are fired from time to time were below 2,500°F. It was also found on this boiler that the furnace exit had a number of individual points that were in a reducing atmosphere, or zero excess oxygen. Nearly all fuels have

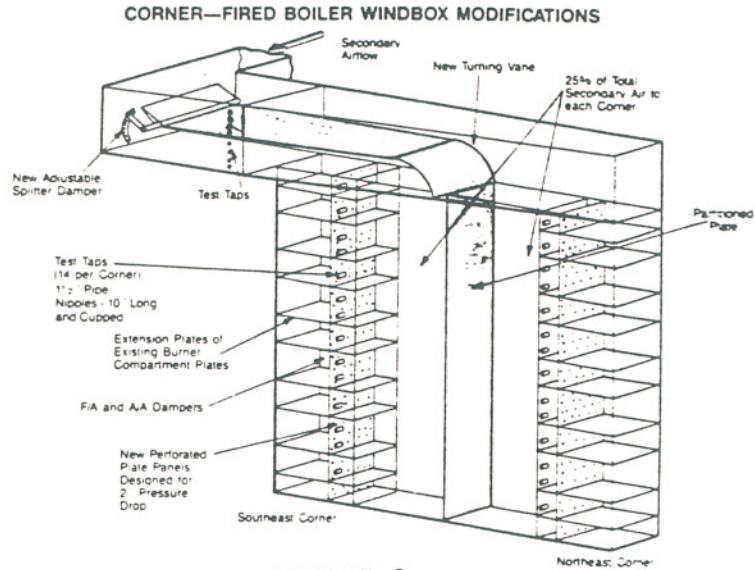
FIGURE 9

Secondary air balancing to each corner was improved by windbox and secondary air duct partitioning, as depicted on Figure 9.

The improved combustion air balance has resulted in being the single largest improvement to reduce slagging in the upper and lower furnace zones. The unit load factor since the changes in 1988 has been increased, with significantly less load reductions for deslagging. The partitioning, perforated plate and division plates have resulted in a retrofit that could be implemented, tuned for optimization, and then easily maintained. The auxiliary air and fuel air dampers are intended for full opening at high load factor. The optimum position "full open" dampers at high load factor are easily duplicated to meet the goal of repeatable furnace exit gas temperatures. During the initial operation, slag at the lower furnace became objectionable. The lower perforated plate sections from each of the four corners was removed to increase the combustion air flow at the lower burner belt zone. This reduced slag formation in this area, and confirmed the boiler's sensitivity to furnace slagging in areas of depleted oxygen.

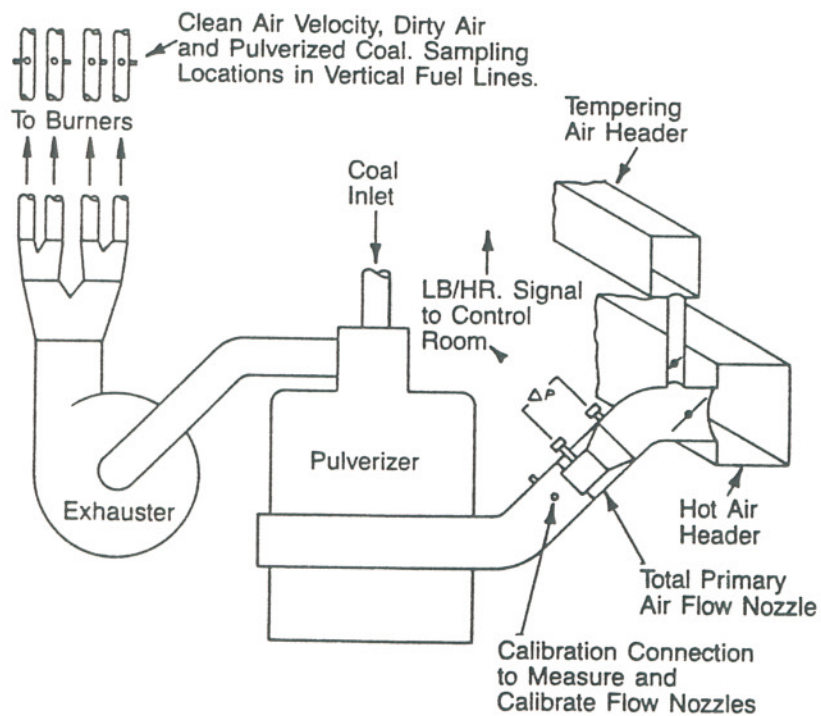
FIGURE 10

Primary air flow measurement and control proved to be important for optimum fuel fineness, flame symmetry in the furnace and for optimum air heater exit gas temperatures.

Subsequent testing has demonstrated that the air heater exit gas temperature is increased in the range of 25 to 30°F by non-optimized (high) tempering air flow.

The primary air flow measurement by round cross-sectional area flow nozzles has provided the capability to measure and control primary air flow to improve accuracy. Precise control of primary air flow to follow a prescribed primary air flow "ramp" requires a third volume control damper, the installation of which is planned for a future outage.

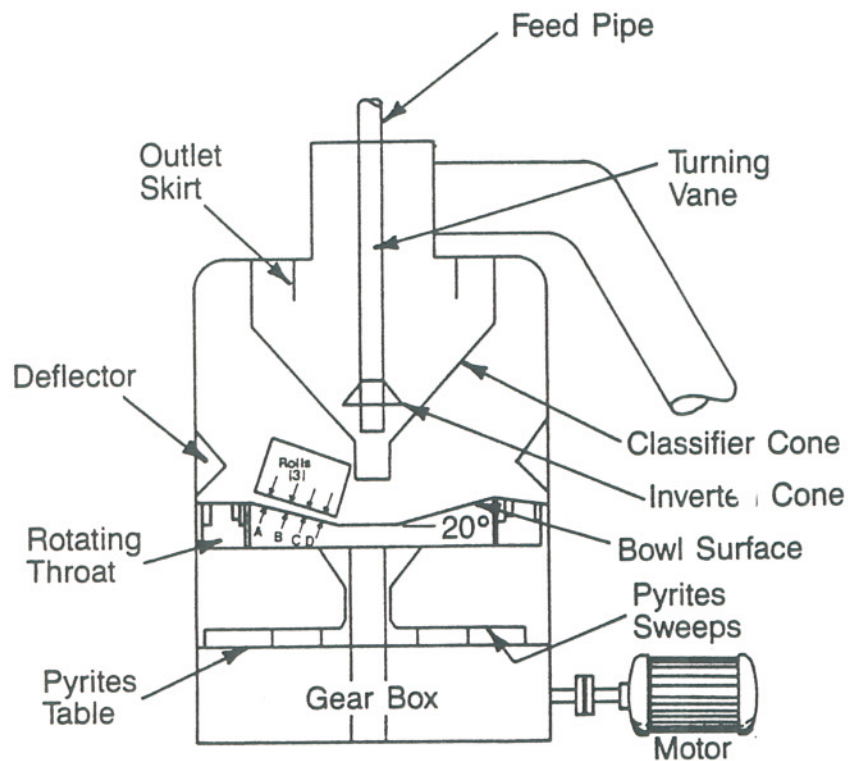
FIGURE 11

Fuel line balancing was completed by clean air traversing of the fuel lines with pitot tubes, and then changing the orifices as required to achieve  $\pm 2\%$  or better balance on a "clean air" basis of each of the four pipes, from each pulverizer.

Fuel balance from the riffle distributors has been satisfactory, providing that the fuel fineness is above 72% passing a 200 mesh screen. Therefore, for fuel balancing, the changes to the pulverizer were to:

- Balance fuel lines on clean air (orifice changes)
- Restore critical roll to ring clearances
- Reduce rotating throat free flow area
- Extend outlet skirt of classifier
- Increase roll pressure for lower HGI fuels
