## ***“Performance, Combustion, and Reliability Optimization of a 360 MW Unit Firing 90% Pulverized Coal and 10% Municipal Solid Waste”***

**Authors:** William H. Furman, E&W Manager, Maintenance  
Jay Chesser, E&W Engineering Technician II  
Thomas J. Reilly, Storm Technologies, Inc. - Consultant

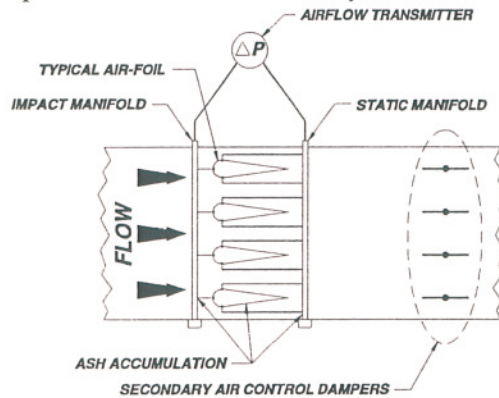
**Figure No. 4 - Air-Foil For Secondary Air Measurement**

1. Secondary air and primary air management was unreliable since ash pluggage in the horizontal type air foils (Figure No. 4), averaging pitot tubes (Figure No. 5) and the sensing lines were common occurrences. Periodic field test proved that the flow calibrations of this equipment would constantly shift, making it difficult for the operators to balance and control the air flow rates. In both cases, the flow measuring devices were replaced using circular flow nozzles (see Figure No. 6) which have resulted in accurate ( $\pm 3\%$ ) repeatable data over the last ten years.

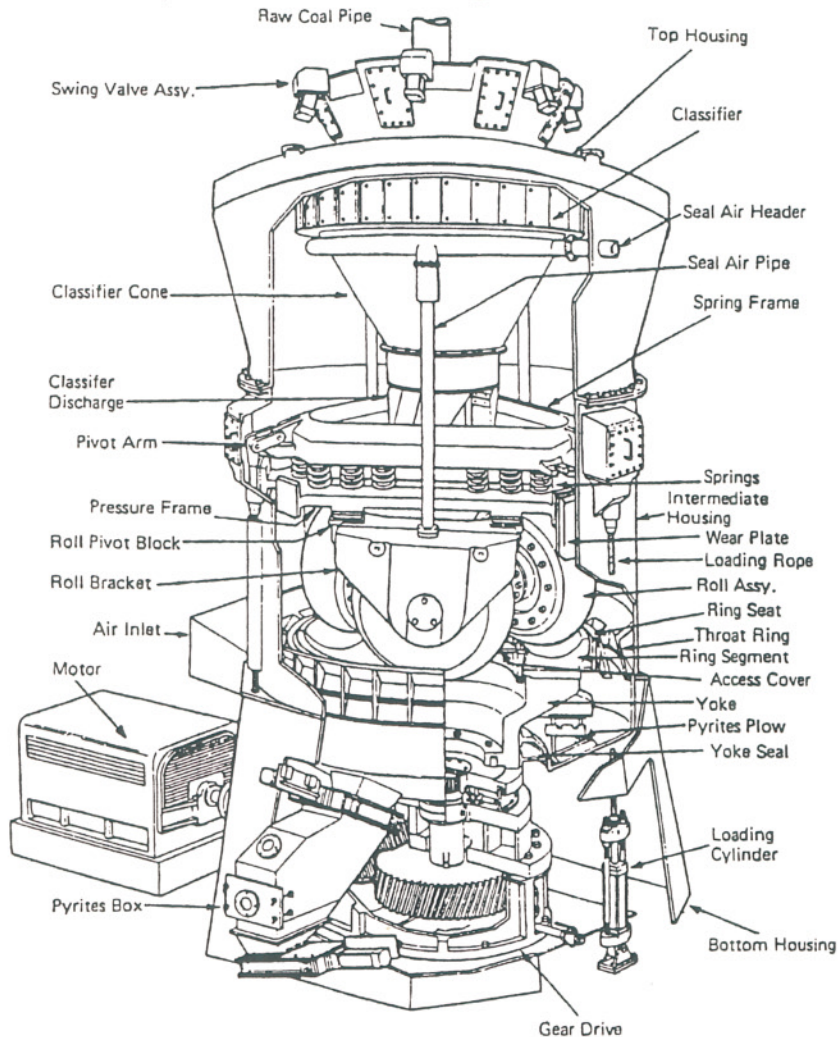
***Figure No. 7 - Cut-Away of MPS Pulverizer***

2. Primary air flow operated at air/fuel ratios of 2.5 pounds air per 1 pound of coal. The four MPS 75 pulverizers (see Figure No. 7) were designed for a 1.8/1.0 ratio. However, due to excessive coal dribble into the pyrite box, the air flows were increased. This caused a reduction in coal fineness, increased coal nozzle wear, and became a factor in unit performance and stack emissions.

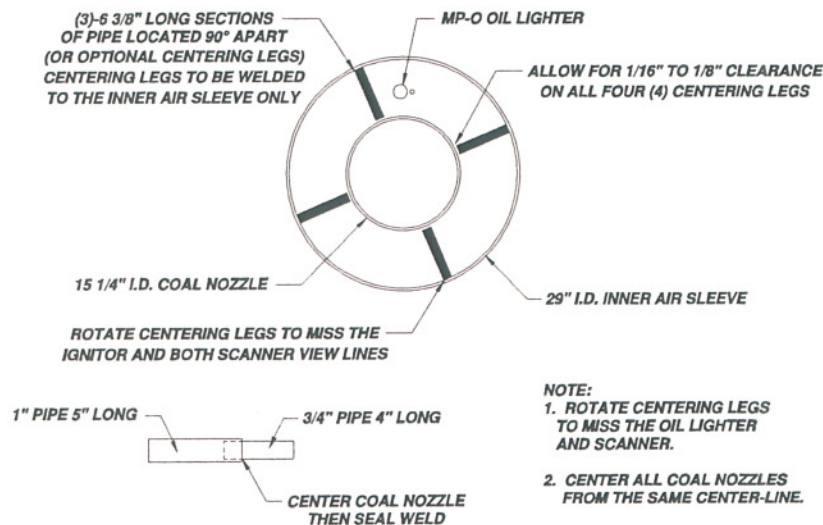
**Figure No. 11 - Coal Nozzle Centering**

3. The coal nozzles were continually out of center since they were over 95" long and supported from the end of the windbox. This would lead to large ash formations around the burner tubes (eyebrows), and would also obstruct the spin vanes, preventing any possible adjustment. Naturally, this also causes poor flow geometry and air/fuel mixing in the burner zone. The coal nozzles were centered using four legs welded to the inner air sleeve and are set to maintain a  $\pm 1/4$ " tolerance (see Figure No. 11).

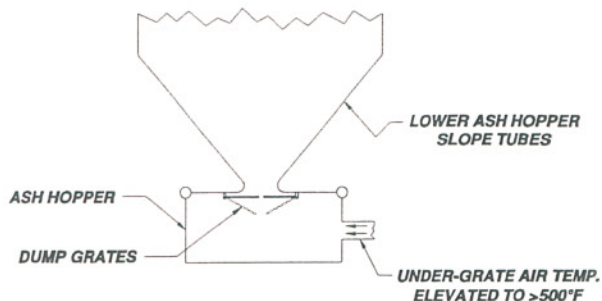
**Figure No. 12 - Conceptual View of Dump Grates**

4. The Municipal Solid Waste (MSW) and/or Refuse Derived Fuel (RDF) burners created various "opportunities for improvement".
- a. Most of the refuse was actually being burned on the dump grates which are located at the furnace bottom ash hopper (see Figure No. 12), while the refuse entered the boiler through four MSW burners (see Figure No. 13) approximately 70' above the grates.

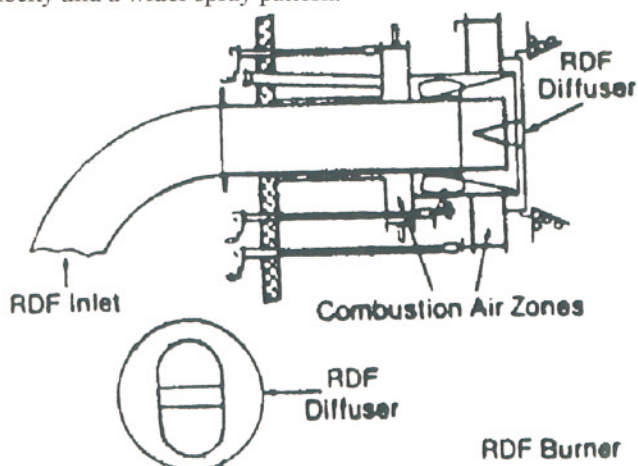
**Figure No. 13 - Original MSW Burner**

- b. The refuse transport air and burner combustion air would dramatically increase the gas mass flow creating excessive, de-superheat spray flows and tube metal temperatures. The MSW burners were modified from the nozzle axis being vertical (see Figure No. 13) to a larger nozzle and positioned with the long axis horizontal (see Figure No. 14). This was completed to create a lower discharge velocity and a wider spray pattern.

- c. The MSW burners, as shown in Figure 13, was a dual register design which provides combustion air around the nozzle. This air was found to actually impact the flue gas mass flow only, and did not contribute to the combustion of the refuse. These registers were removed and refractory was installed to close off the opening, as shown in Figure No. 14. This assisted in the reduction of superheat spray water flow rates from over 12% of steam flow to about 9%.

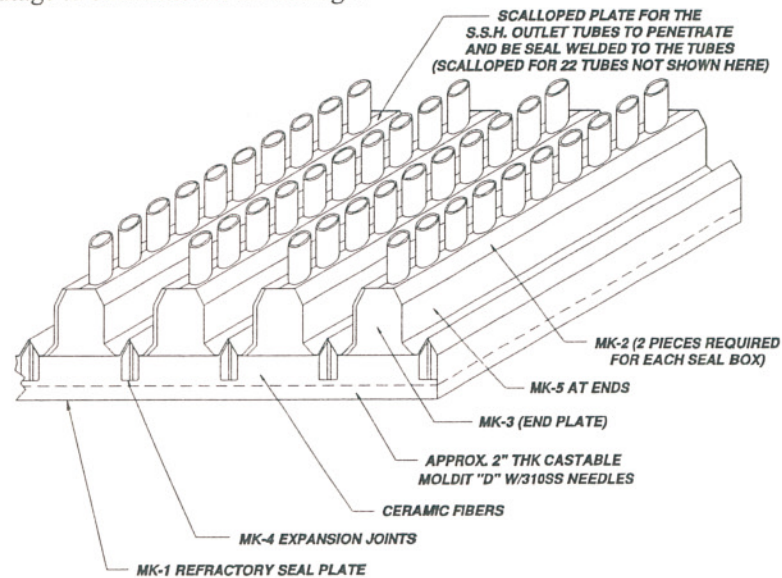
***Figure No. 15 - Conceptual View of High Crown Seals***

5. This Unit also experienced high quantities of air infiltration through the damaged metal seals in the Penthouse. This air would not contribute to the combustion of the fuel. However, it would be measured by the economizer exit gas oxygen analyzers. Due to this, the actual operation of the unit was well below the required excess oxygen necessary in the combustion zone for optimum performance. Since 1992, the Unit has had new seals (see Figure No. 15) and weld repairs performed during each outage to eliminate the air leakage.

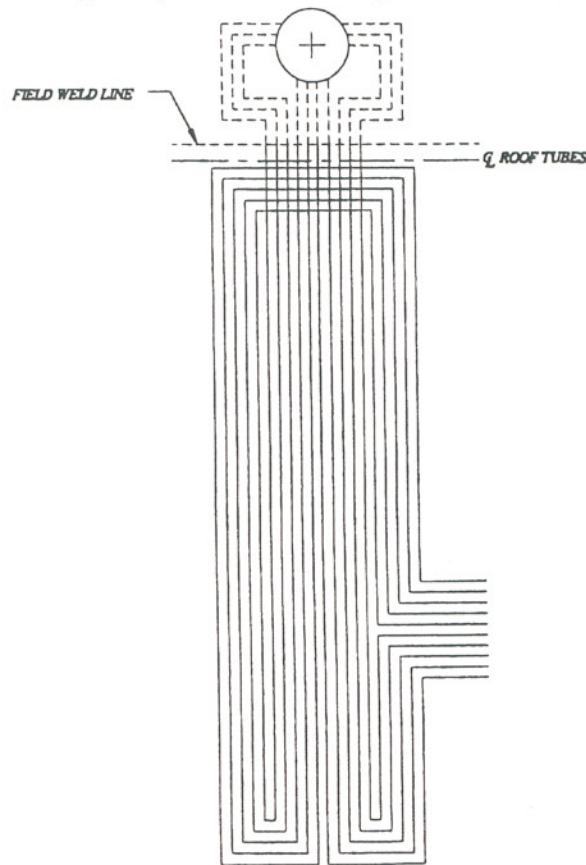
**Figure No. 16 - Reheater Outlet Assembly Replaced in 1993(57 Required)**

1. In 1992, the reheater outlet bank (see Figure No. 16) experienced tube wastage due to fluid "coal ash corrosion". This was after only ten (10) years of operation. Some tube wall thickness' were below 0.100", while original minimum wall thickness was .203". The tubes had a 50% reduction in wall thickness due to gas temperatures measured by a water-cooled High Velocity Thermocouple (HVT) operating at 2,000°F to 2,200°F, while tube metal thermocouples were between 1,050°F and 1,125°F. The following graph shows that these tubes were mostly operating in the corrosive zone.

The flue gas and metal temperatures would increase when MSW burners were "in service". For this reason, as well as the metallurgical evaluation and ash analysis, we decided to upgrade the fifty-seven (57) assemblies from SA213T-22 (Chrome-Moly) to SA213TP304 (Stainless Steel). This was completed in 1993 and, to date, the tubes have little to no ash accumulation while the original tubes had to be mechanically cleaned during each annual outage. Combustion optimization has also improved the life of the new reheater tubes since the tube metal temperatures have been reduced to no tubes above 1,070°F and flue gas temperatures consistently remain below 2,000°F.

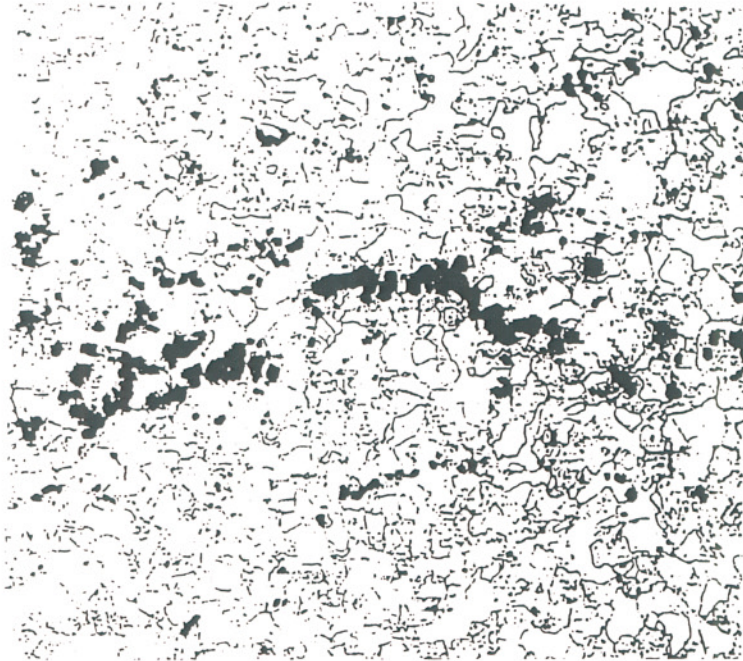
***Figure No. 17 - Chain Graphidization in SA-209-T1A Tubes***

- In 1993, the primary superheater tubes, upper bank experienced tube ruptures due to chain graphidization (see Figure No. 17). The metallurgical evaluation showed that these tubes have operated above 900°F for extended periods causing the long term failures. The following graph shows primary superheat tube metal temperatures for September 3, 1993.

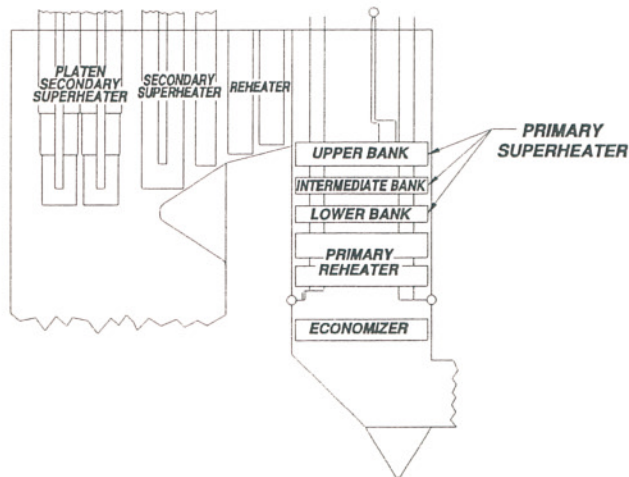
**Figure No. 18 - Convection Pass Showing Primary Superheater**

It is evident that these tubes, which are fabricated from SA209T1A (Carbon-Moly) material, were definitely operating above their allowable range. An evaluation was conducted using numerous tube samples from the upper, intermediate, and lower banks of the primary superheater (see Figure No. 18). Numerous tests were conducted of the flue gas temperature above and below each bank as well as recording of the PSH outlet tube metal thermocouples, PSH outlet steam temperatures, and spray water flow rates. Our resolution consisted of modifying, upgrading, and replacing the upper and intermediate banks of the primary superheater. Our changes were based on the following calculations:

The following is the design change that was completed on the upper bank while the material on both the upper and intermediate was upgraded to SA213T-11.
