“SHOCK WAVE” IMPULSE CLEANING DEVICE CASE STUDY

- PowerPlus Cleaning Systems’ IMPULSE® Cleaning Technology
- A 90-Day Review of “Impulse Cleaner” utilization

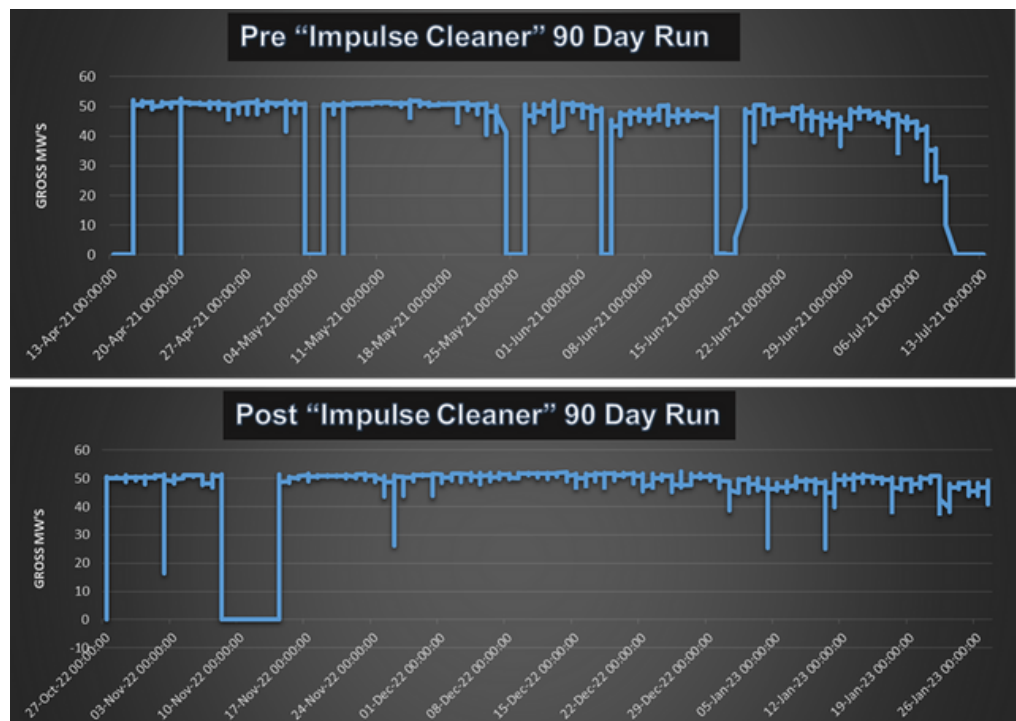
Figure 1: Pre/Post Impulse Cleaner 90-Day Operation to Compare Maintenance Outages

As shown in Figure 1, there were approximately seven outages over a 90-day period compared to one forced outage after the impulse cleaning devices were installed. This is the first operational run for more than 90 days without requiring an outage to water wash the boiler; gaining approximately ten days of additional run time over the 90-day period with these fuels. This resulted in more Mw generation and reduced maintenance/sub-contractor costs to water wash the boiler.

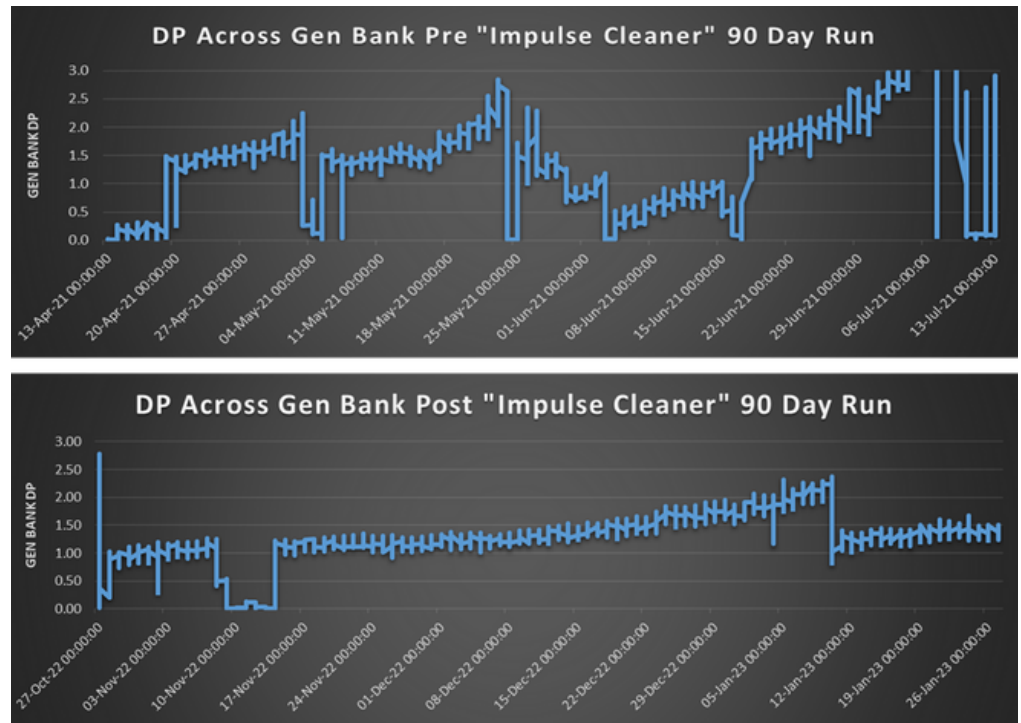
Differential pressure across the generating bank of the boiler has long been a telltale sign of the boiler plugging. This differential impacted fan capacity and was the key indicator when the unit needed to come offline for water washing to regain capacity. Figure 2 illustrates the generating bank differential pressure over the 90-day operation (pre and post-impulse cleaner). The drop on the “Post” impulse cleaner towards the end was an online water cleaning. Overall, the unit was able to maintain acceptable differential pressure over the 90+ day operational run with the impulse cleaners in place.

Figure 2: Pre/Post Impulse Cleaner 90-Day Operation to Compare Generation Bank Differential Pressure

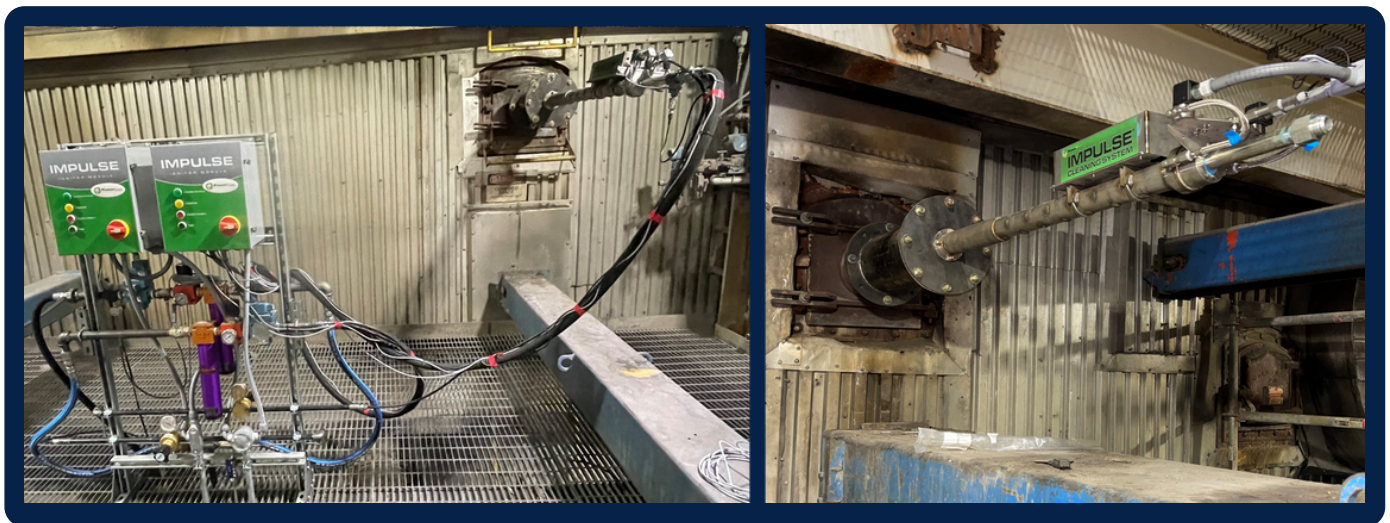
Going into the trial of the IMPULSE® cleaning technology at this facility, Storm knew that the unit experienced aggressive slagging and fouling in the superheater and generating bank. Therefore, STORM wanted to maximize our ability to keep these areas clean. So four of these devices were installed. Two devices were located on opposite walls in both the superheater and generating bank. Figure 3 shows the general arrangement of the impulse cleaner located in the generating bank and the inlet to the generating bank. There is a total of four impulse cleaners on opposite sides of the boiler.

Figure 3: Impulse Cleaner General Arrangement (Typ. 4 Locations)

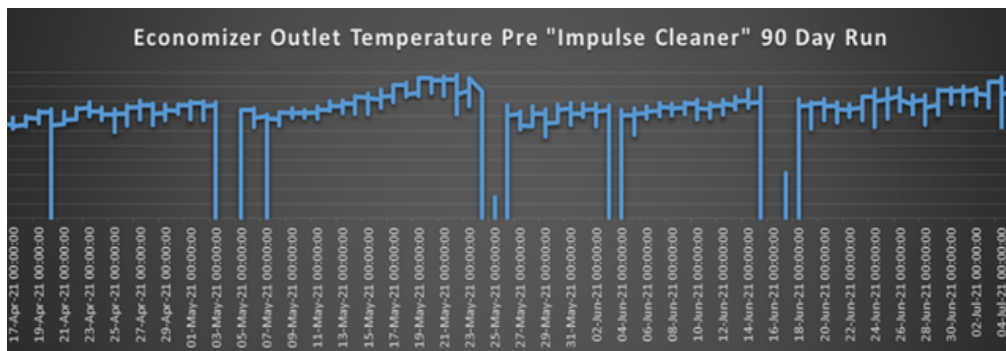
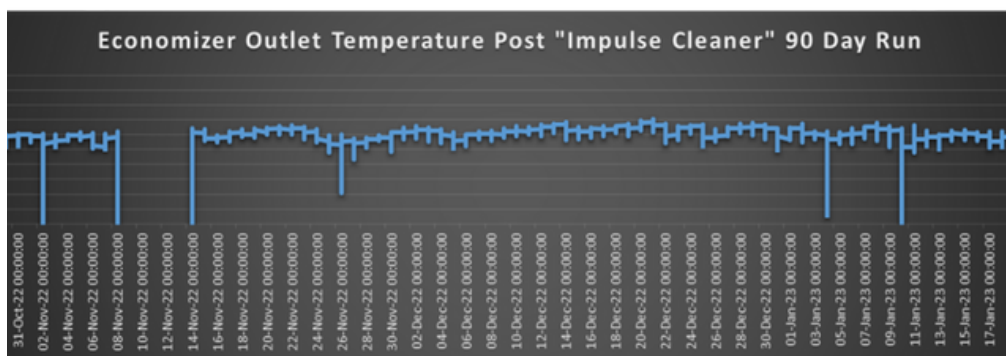
In addition to increasing the boiler operation to 90+ days with the impulse cleaner and due to reduced draft losses, we have also seen a reduction in economizer exit gas temperatures as a result of the cleaner tubes in the generating bank. Based on the operational data pre/post impulse cleaner for the 90-day period (Figure 5), it is clear that the average economizer outlet temperature is approximately 20°F less (from around 525°F - 545°F to 510°F - 520°F); which is a boiler efficiency improvement. Furthermore, there is no significant upward trend in gas temperature over this 90-day period.

Figure 5: Econ. Outlet temp. reduction after Impulse Cleaner 90+ days of operation

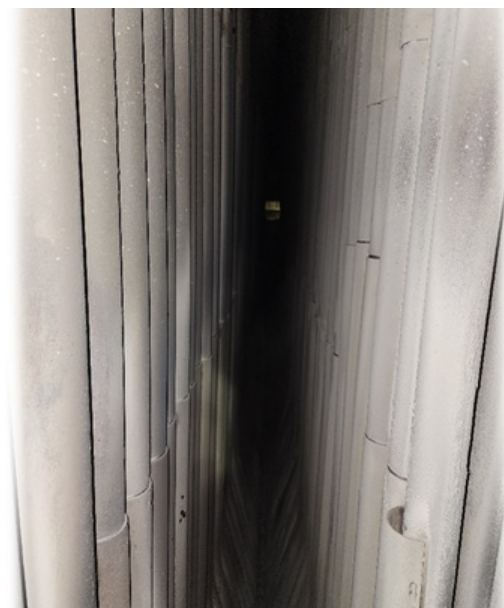
Based on the initial installation and operating period, over a yearly timeframe, this system should allow for an additional 30 to 40 operational days of Mw generation and provide a significant reduction in maintenance or water washing of the unit over this period. Figure 4 below shows the cleanliness of the generating bank after 90 days of operation.

Figure 4: Generating Bank after 90+ days of operation (Much cleaner than before impulse cleaner)
