# **PULVERIZED COAL BOILER OPTIMIZATION THROUGH FUEL/AIR CONTROL**

**Barry E. Pulskamp, P.E.  
Director, Mechanical Engineering  
Cincinnati Gas & Electric Company**

**This paper presented at the Thirtieth Annual Kentucky Coal  
Utilization Conference, University of Kentucky, April 24 and 25, 1991.**

1.0 BACKGROUND AND  
DESCRIPTION OF UNIT

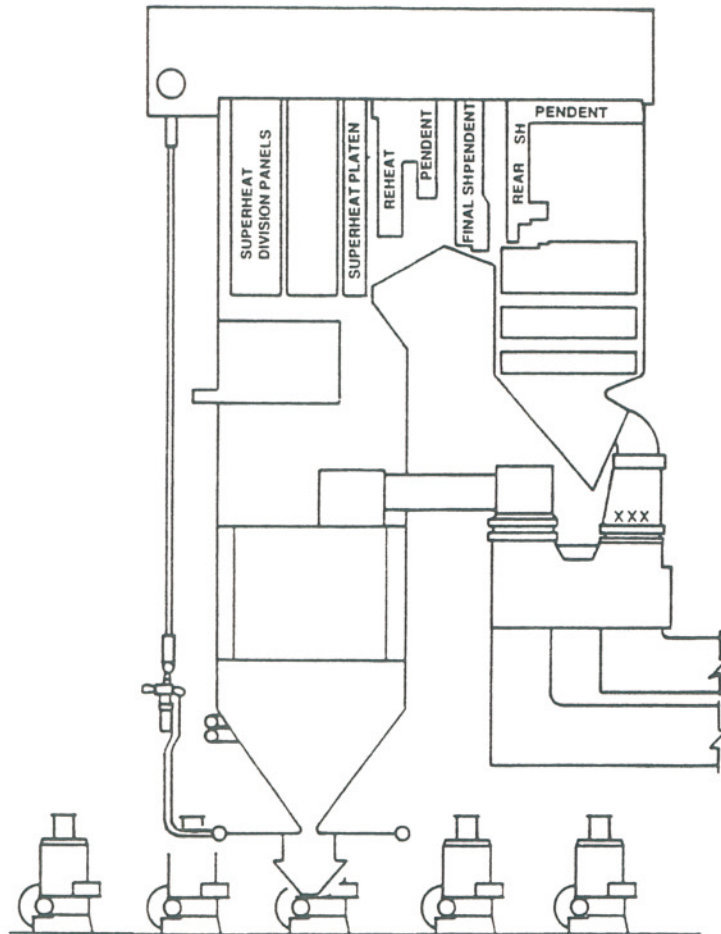
FIGURE 1

The W. C. Beckjord Unit No. 6 is a nominal 440 Mw pulverized coal fueled unit. The steam generator is a four corner, corner fired boiler designed by Combustion Engineering Company. Pertinent design data for the boiler are shown on Figures 1 through 3.

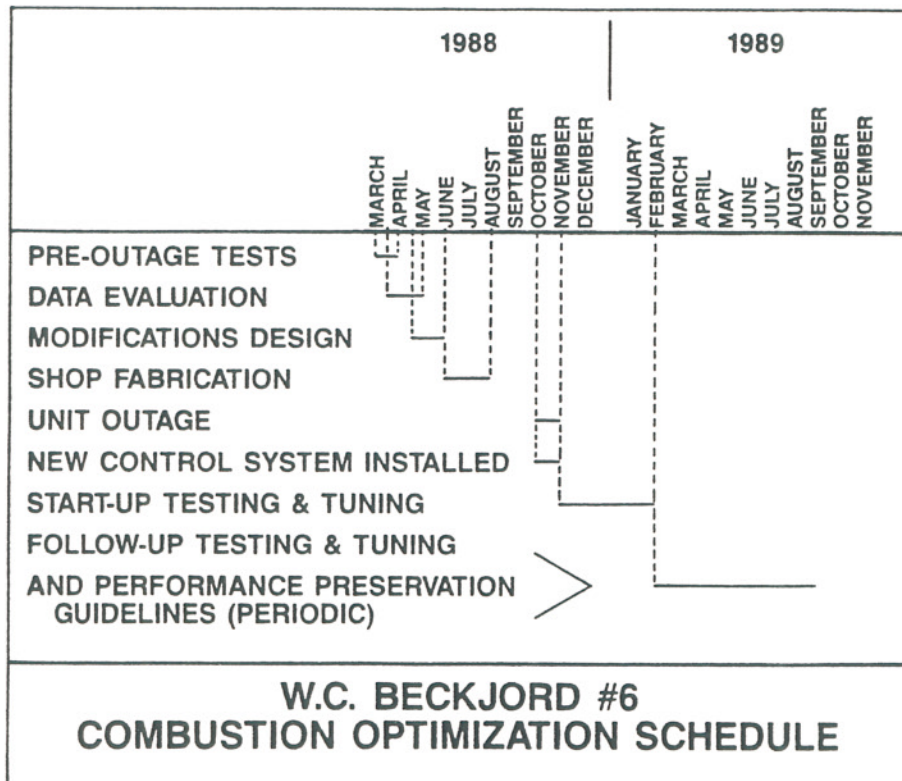
FIGURE 7

Once the opportunities for improvement were identified, the modifications were designed for implementation during the scheduled Fall 1988 outage. The project schedule is shown on Figure 7, as the testing and modifications were actually completed.

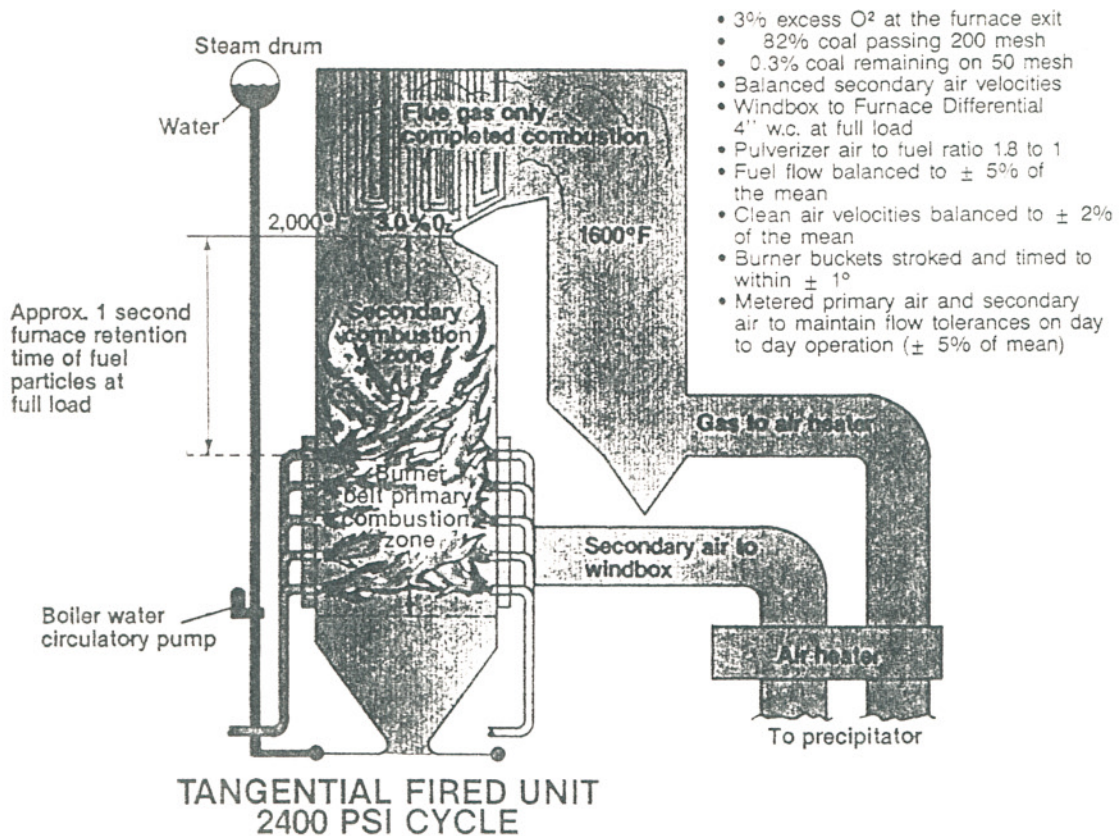
Ten prerequisites for optimum combustion were identified, and the modifications were designed to address each of these. Figure 8 outlines the prerequisites for optimum combustion.

- SECONDARY AIR BALANCING
- BURNER TILT/TIMING
- FUEL BALANCING
- REDUCE AIR-IN-LEAKAGE
- CONTROL PRIMARY AIRFLOW

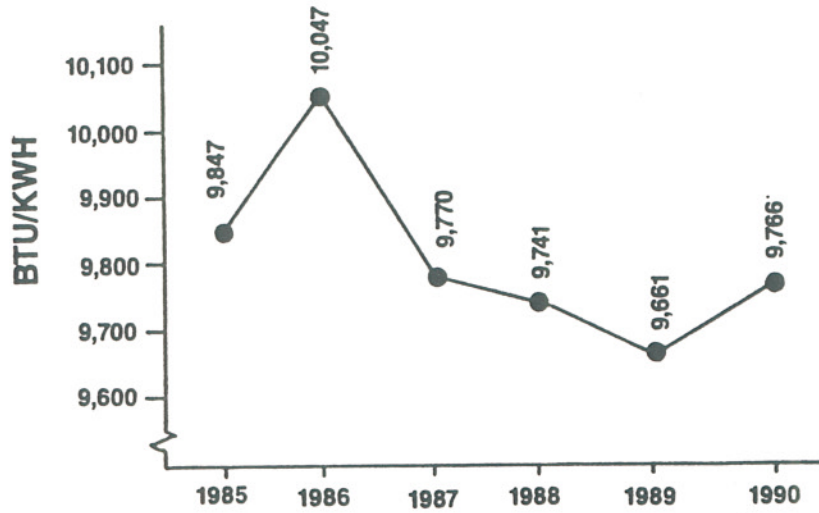
FIGURE 14

The heat rate and capacity factor graphs for the recent past are shown on Figures 14 and 15.

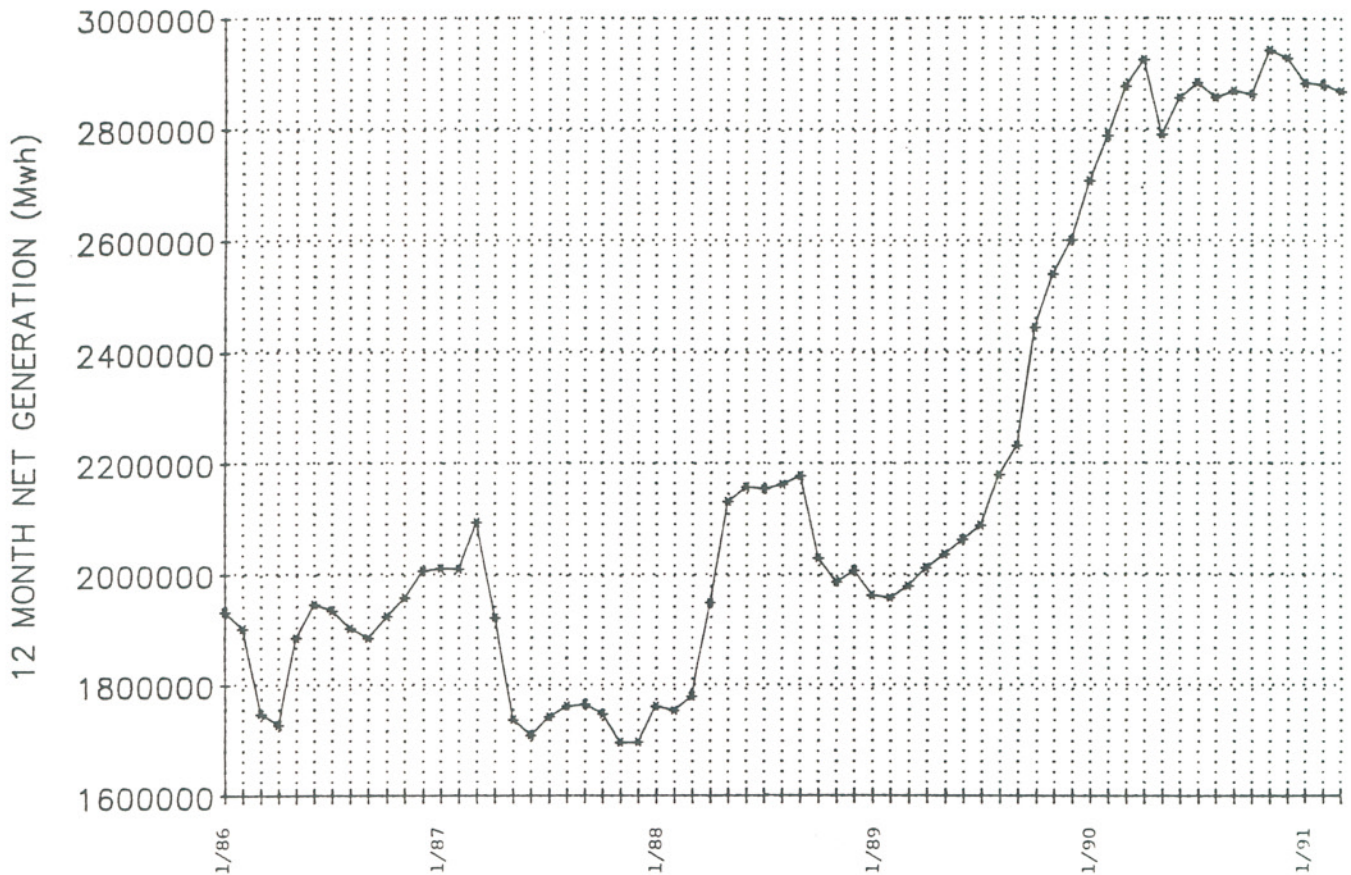
W.C. BECKJORD STATION - UNIT 6  
12 MONTH GENERATION SINCE 1-1-86

The twelve-month generation, in net megawatts, is shown on Figure 16.
