## ***“Performance, Combustion, and Reliability Optimization of a 360 MW Unit Firing 90% Pulverized Coal and 10% Municipal Solid Waste”***

**Authors:** William H. Furman, E&W Manager, Maintenance  
Jay Chesser, E&W Engineering Technician II  
Thomas J. Reilly, Storm Technologies, Inc. - Consultant

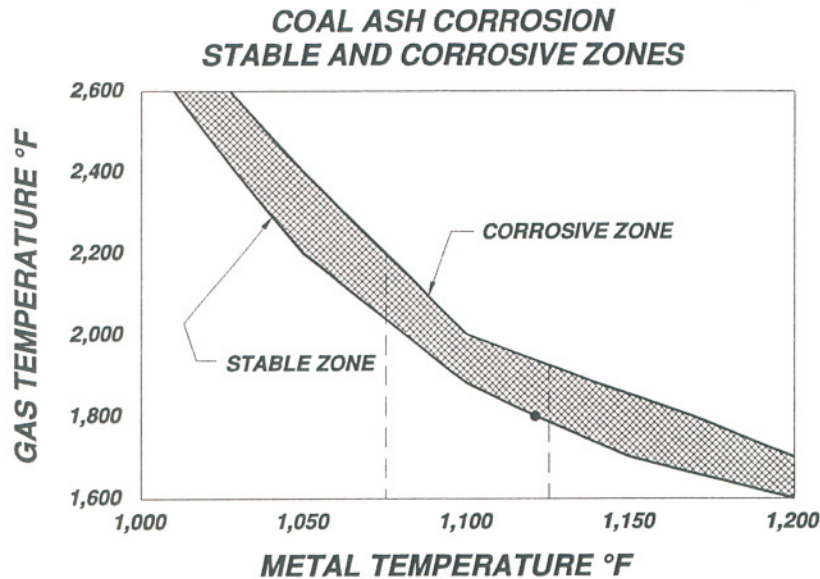
1. In 1992, the reheater outlet bank (see Figure No. 16) experienced tube wastage due to fluid "coal ash corrosion". This was after only ten (10) years of operation. Some tube wall thickness' were below 0.100", while original minimum wall thickness was .203". The tubes had a 50% reduction in wall thickness due to gas temperatures measured by a water-cooled High Velocity Thermocouple (HVT) operating at 2,000°F to 2,200°F, while tube metal thermocouples were between 1,050°F and 1,125°F. The following graph shows that these tubes were mostly operating in the corrosive zone.

The flue gas and metal temperatures would increase when MSW burners were "in service". For this reason, as well as the metallurgical evaluation and ash analysis, we decided to upgrade the fifty-seven (57) assemblies from SA213T-22 (Chrome-Moly) to SA213TP304 (Stainless Steel). This was completed in 1993 and, to date, the tubes have little to no ash accumulation while the original tubes had to be mechanically cleaned during each annual outage. Combustion optimization has also improved the life of the new reheater tubes since the tube metal temperatures have been reduced to no tubes above 1,070°F and flue gas temperatures consistently remain below 2,000°F.

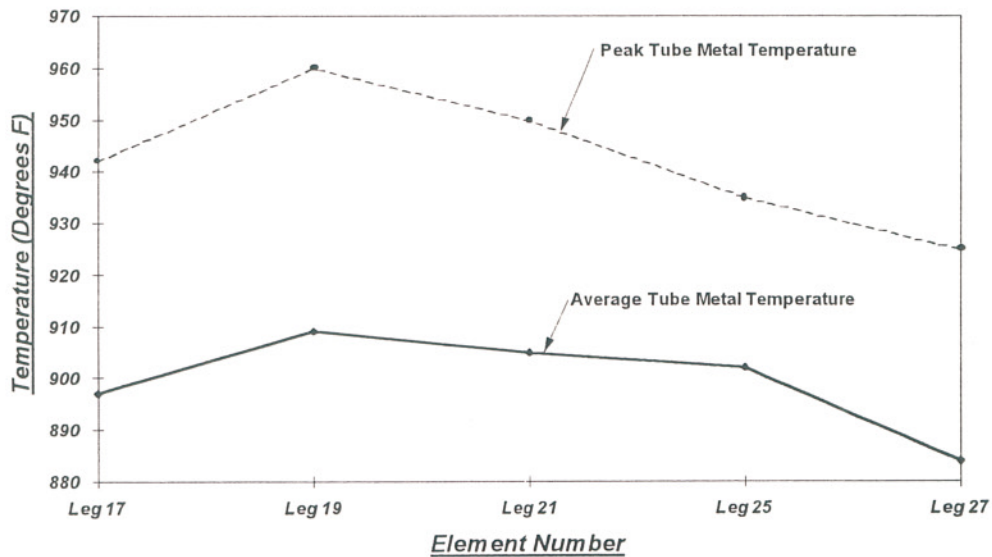
***Primary Superheater Tube Metal Temperatures***

- In 1993, the primary superheater tubes, upper bank experienced tube ruptures due to chain graphidization (see Figure No. 17). The metallurgical evaluation showed that these tubes have operated above 900°F for extended periods causing the long term failures. The following graph shows primary superheat tube metal temperatures for September 3, 1993.

It is evident that these tubes, which are fabricated from SA209T1A (Carbon-Moly) material, were definitely operating above their allowable range. An evaluation was conducted using numerous tube samples from the upper, intermediate, and lower banks of the primary superheater (see Figure No. 18). Numerous tests were conducted of the flue gas temperature above and below each bank as well as recording of the PSH outlet tube metal thermocouples, PSH outlet steam temperatures, and spray water flow rates. Our resolution consisted of modifying, upgrading, and replacing the upper and intermediate banks of the primary superheater. Our changes were based on the following calculations:

The following is the design change that was completed on the upper bank while the material on both the upper and intermediate was upgraded to SA213T-11.

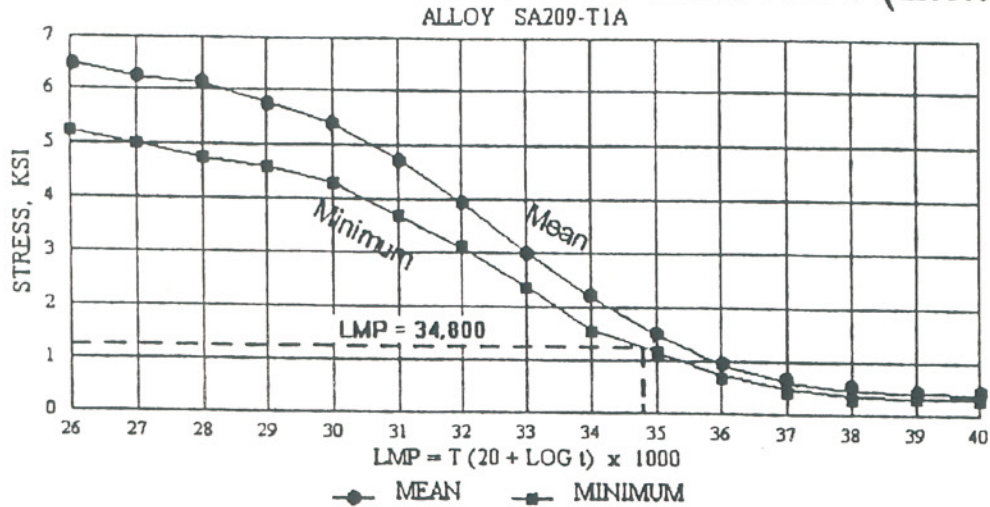
**Figure No. 19 - Carbon/Moly - SA-209-T1A**

A remaining life assessment can be determined from the Larson Miller Parameter (LMP) at a stress value of 12,200 psi and different temperatures. A LMP value of 34,800 for SA-209-T1A can be found from Figure No. 19 and a LMP value of 35,200 for SA-213-T11 is found from Figure No. 20.

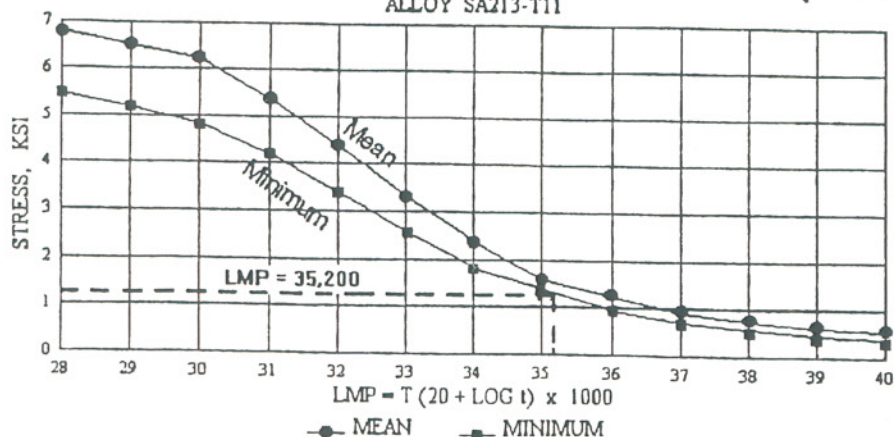
**Figure No. 20 - Chrome/Moly - SA-213-T11**

- SA213-T11 @900°F Tube Metal Temp.  
 ≈ 95 yrs.
- SA213-T11 @925°F Tube Metal Temp.  
 ≈ 32.5 years
- SA213-T11 @950°F Tube Metal Temp.  
 ≈ 11.5 years

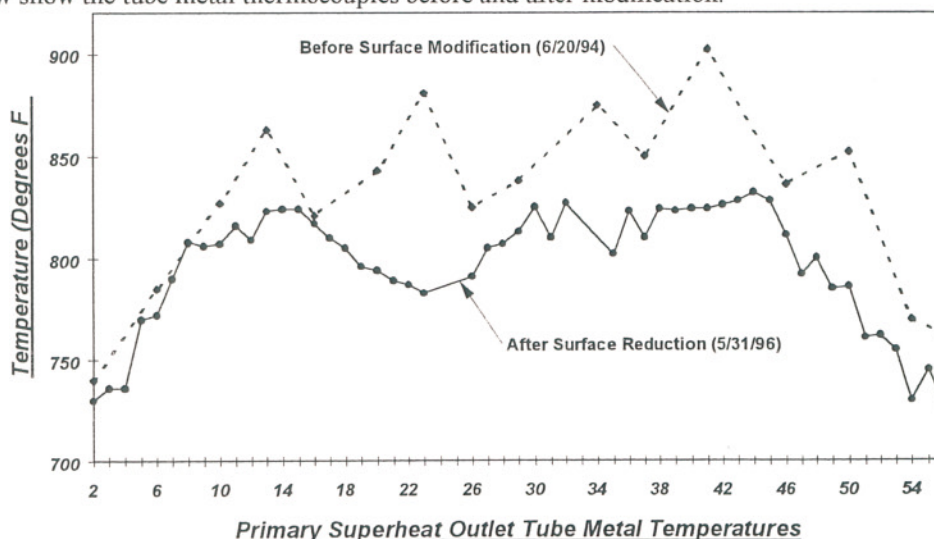
The primary superheat modification has reduced spray water flow rates from 220,000 lbs/hr to 160,000 lbs/hr and the average tube metal thermocouples are 35°F lower at about 790°F. The graph below show the tube metal thermocouples before and after modification.
